A MAJOR GULF COAST TANK FARM USES UHP WATERJETTING FOR FIBERGLASS LINER REMOVAL USING MULTI -CRAWLER SYSTEM

DESCRIPTION OF PROJECT

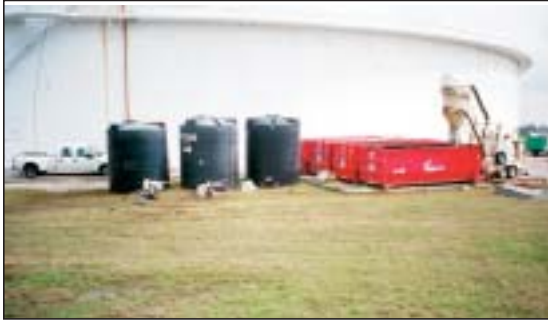
Liner Removed using the JetTrac™ System

UHP Projects, Inc. proposed removing the fiberglass liner and lead based primer with the remotely controlled, vacuum attached, multi-crawler **JetTrac™ system**.

- ◆ This system uses Ultra High-Pressure (40,000-PSI) waterjets to strip the coatings from the surface.
- ◆ The **JetTrac™** system is an omni-directional vacuum attached system that can crawl over any surface - vertical, horizontal or overhead.

- ◆ A patented seal allows the remote **JetTrac™** crawler to attach itself to the surface, using vacuum supplied by a remote vacuum skid. The coating and water is completely contained in a vacuum shroud and removed down a hose to a vacuum system located outside the tank.
