### A MAJOR GULF COAST TANK FARM USES UHP WATERJETTING FOR FIBERGLASS LINER REMOVAL USING MULTI-CRAWLER SYSTEM

#### DESCRIPTION OF PROJECT

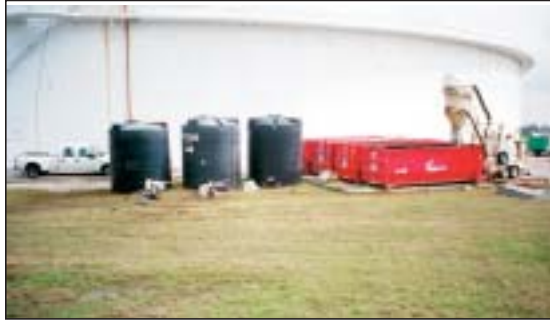
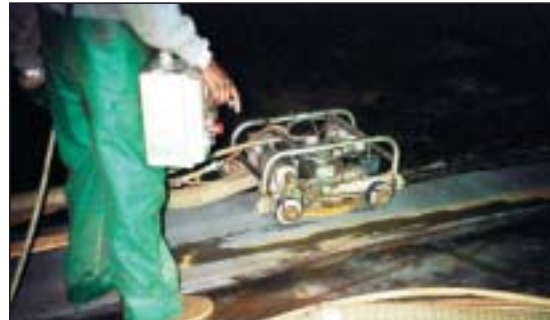
# Liner Removed using the JetTrac™ System

UHP Projects, Inc. proposed removing the fiberglass liner and lead based primer with the remotely controlled, vacuum attached, multi-crawler **JetTrac™ system**.

- ◆ This system uses Ultra High-Pressure (40,000-PSI) waterjets to strip the coatings from the surface.
- ◆ The **JetTrac™** system is an omni-directional vacuum attached system that can crawl over any surface - vertical, horizontal or overhead.

- ◆ A patented seal allows the remote **JetTrac™** crawler to attach itself to the surface, using vacuum supplied by a remote vacuum skid. The coating and water is completely contained in a vacuum shroud and removed down a hose to a vacuum system located outside the tank.

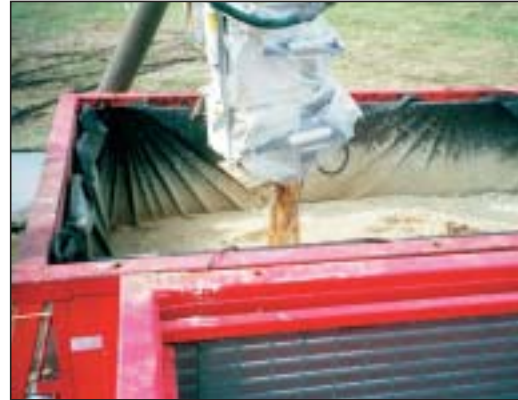
*Effluent water and solids from JetTrac™ vacuum system.*

UHP Projects designed a filtration system to recycle the effluent jetting water to minimize the volume of water and to reduce the overall cost of the project. Once the waterjetting was completed all the water ran through the filter system removing all solids, reduced the lead level, COD's, chlorides, zinc and balanced the pH all below the states requirements. After filtration all water was pumped back into the owners drainage system at the end of the project.
